Manhole Inspection Summary

Manhole # S23C1_002MH

Insp Date: **7/3/08 11:25 AM**

Location Address: **2410 Huron St**

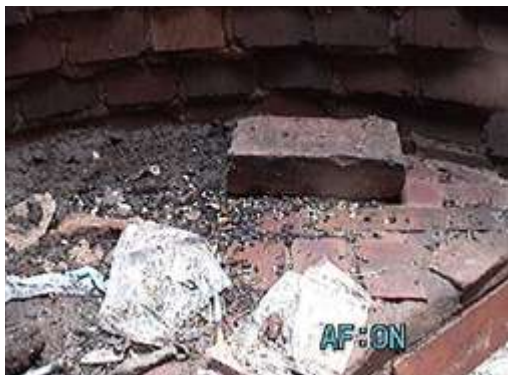
Miscellaneous

debris on bench

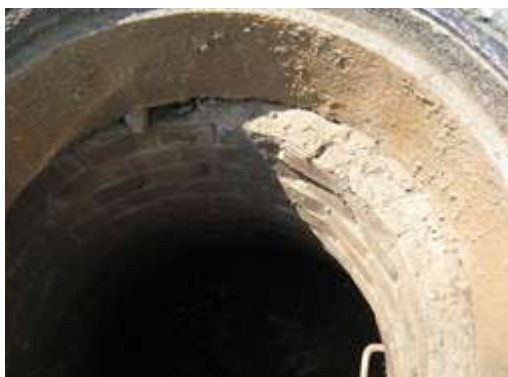
Defect 3

Frame Offset: **2.** (in.) Condition: ☐ Sound ☐ Cracked ☒ **Leaks**
25

frame lid infiltration, frame offset

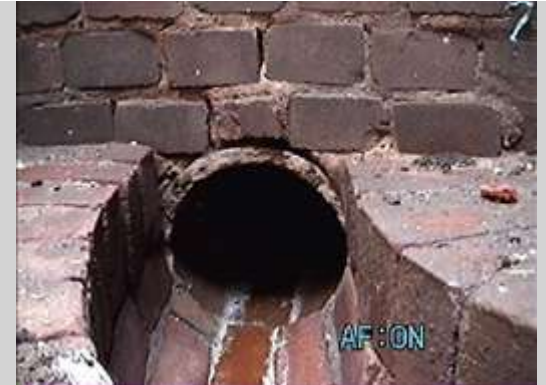
12 O'Clock Outflow

8 in. Circular Gravity Sewer
Pipe Out @ 12 O'Clock

Pipe Height: **8.4** (in.) Rod and Bar (Angled)
Pipe Material: **Clay** ☐ Pipe Lined
Invert Depth: **7.75** (ft.) Flow Characteristics: **Slow**
Deposits: ☒ None ☐ Mud ☐ Sludge ☐ Debris ☐ Grease
Silt Depth: **0** (in.) Deposits Extent:
Infiltration: **None** Pipe Seal Cond: **Sound**

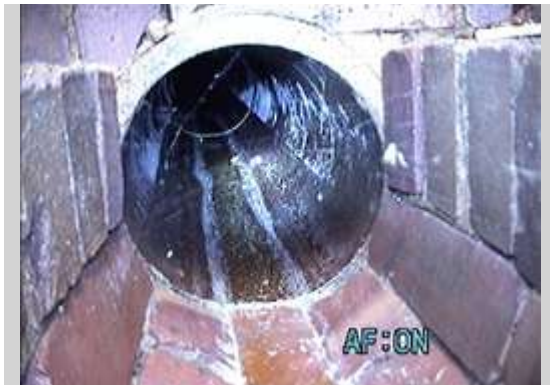
4 O'Clock Inflow

8 in. Circular Gravity Sewer
Pipe In @ 4 O'Clock

Pipe Height: **8.4** (in.) Rod and Bar (Angled)
Pipe Material: **Clay** ☐ Pipe Lined
Invert Depth: **7.65** (ft.) Flow Characteristics: **Slow**
Deposits: ☒ None ☐ Mud ☐ Sludge ☐ Debris ☐ Grease
Silt Depth: **0** (in.) Deposits Extent:
Infiltration: **None** Pipe Seal Cond: **Sound**

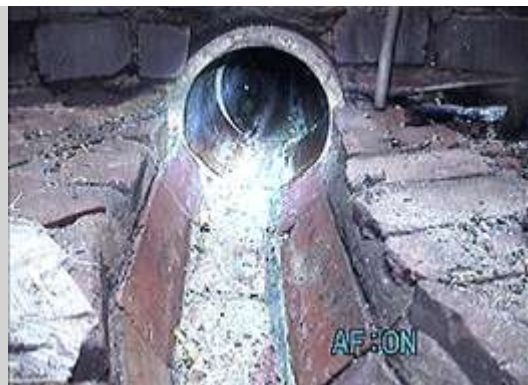
8 O'Clock Inflow

6 in. Circular Gravity Sewer
Pipe In @ 8 O'Clock

Pipe Height: **6** (in.) Rod and Bar (Angled)

Infiltration: **None**

Pipe Seal Cond: **Sound**
